# Inspector Bulletin

Latest updates & News feeds for Inspectors. 06th Dec 2019

**VIQ 5.39** Are officers aware of the requirements for testing fixed fire detection and alarm systems and are the systems in good order and tested regularly?

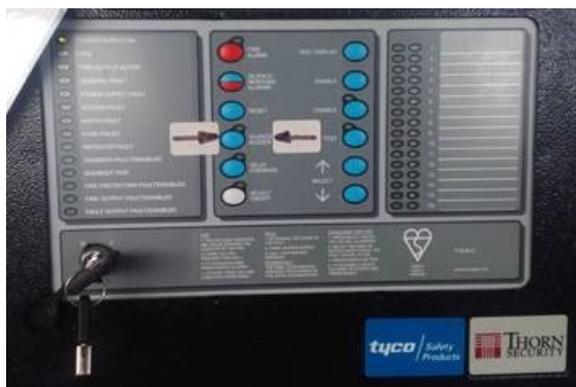
**Inspector Observation:** There was no fire detection sensor in the Navigation Bridge which was a control station, therefore bridge was not protected by fire detection during cargo operations when bridge was unmanned. The nearest sensor was located outside the bridge behind the internal bridge entrance fire door.

Initial Operator Comments: Ship was constructed on 2011 (vessel's keel laid on 09 Sept 2011) and delivered to her owners on 17th Feb 2012 being fully compliant with applicable rules & regulations at the time of construction. However, following the observation we are in contact with Classification Society in order to ascertain if further actions are required.

In this case here there is no requirement for the fitting of sensors, however the VIQ guidance does require regular fire rounds during periods of the bridge being unmanned. In this case, inspectors should verify that a regular fire round covers the bridge during these unmanned periods. This also applies to other areas that are not protected with fixed fire detection equipment.

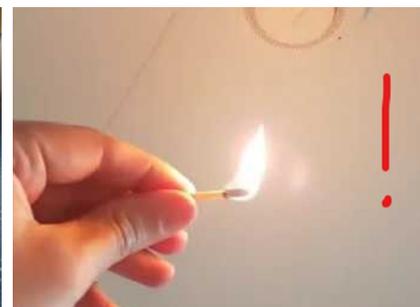
**Inspector Observation:** The vessel was not provided with the correct equipment for testing of the flame and heat detectors onboard. A non-approved heat gun was reported to have been used for such testing rather than the correct flame and heat testers as recommended by the makers instruction booklet.

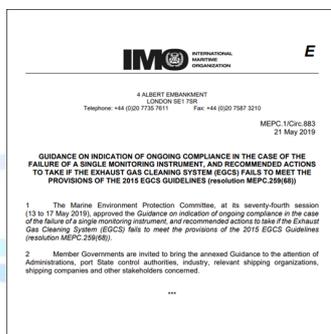
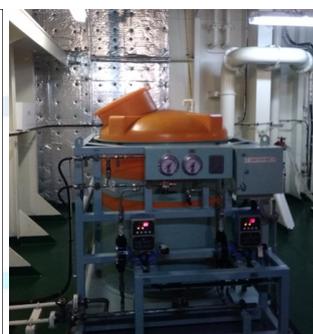
## Exhaust Gas Cleaning System Failures

With the 2020 sulphur cap deadline approaching and the numerous installations of exhaust gas cleaning systems on vessels the IMO have introduced guidance on actions in the event of failure of such systems.

This Guidance letter <https://www.mardep.gov.hk/en/msnote/pdf/msin1917anx3.pdf> specifies that a short-term temporary emission exceedance due to the system failure should not be considered as a breach, and the system malfunction that cannot be rectified within one hour is regarded as a breakdown and should be reported to flag States and port State's Administration. The Guidance also specifies the procedures to show the ongoing compliance, in case of the failure of a single monitoring instrument, with other parameters continuing at the normal levels. (Refer to MEPC.1/Circ.883 as attachment 14).
