Inspector Bulletin

Latest updates & News feeds for Inspectors. 2nd June 2020

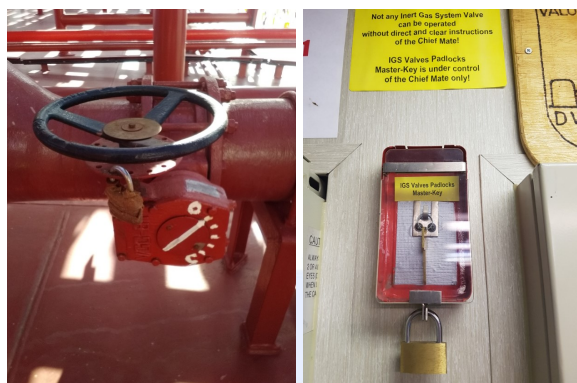
Here is a good example of well managed inert gas tank valve arrangements

Here we have the padlocks protected so that they can be opened easily and a clear statement in the CCR as to the level of authority for the control of these valves.
