Inspector Bulletin

Latest updates & News feeds for Inspectors. 12th Nov 2020

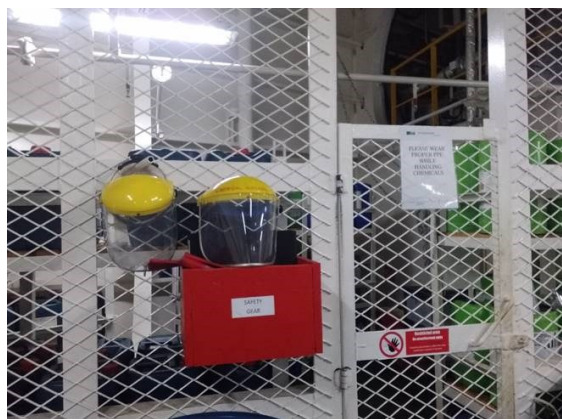
Nice example of best practice here with the PPE placed outside of the chemical locker such that this can be donned prior to entering the locker itself.

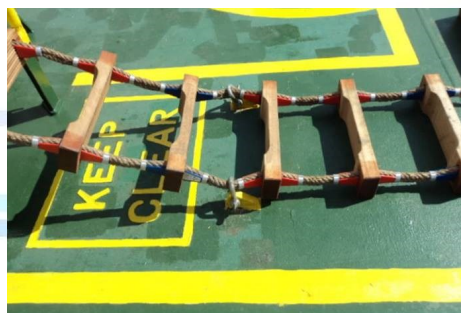
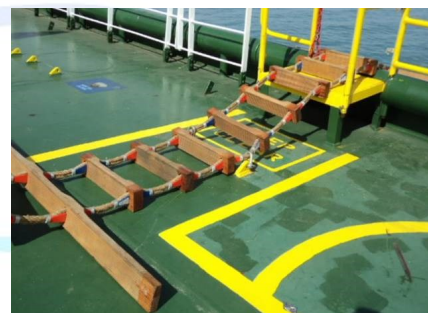
Inspectors Observation The company procedure had not defined means to rig the pilot ladder and the deck hands who engaged in rigging the pilot ladders confirmed that the pilot ladder was secured to the deck rings with two steel shackles on the ladder side ropes, by such rigging arrangement, the ladder spacers took the weight of the ladder. (Reference: Code of Safe Working Practices for Merchant Seafarers, Chapter 22.10.)

This above arrangement is **NOT** acceptable and should be two designated strops constructed from manila rope with a breaking strength of no less than 2.4 metric tonnes/24 Kilo Newtons (typically 18mm diameter). The strops should be secured to the deck strong points and then secured around the side ropes of the ladder between the steps by means of a rolling hitch as follows;

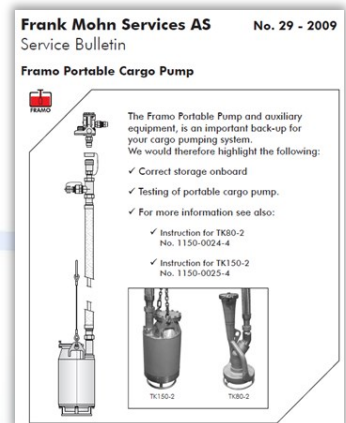
Inspectors observations: Vessel was provided with 2 Multi-chem 4" x 24 meters Framo cargo hoses which were annually tested for continuity by ship's staff. However, hydrostatic and elongation tests for both cargo hoses as required by ISGOTT chapter 18.2.6.1 were not performed on board and were not included in the Company SMS.

Further, Makers Service Bulletin No.29 stated *The cargo hose for the portable pump to be tested and maintained according general in forced rules and procedures valid for cargo hoses onboard the vessel.*

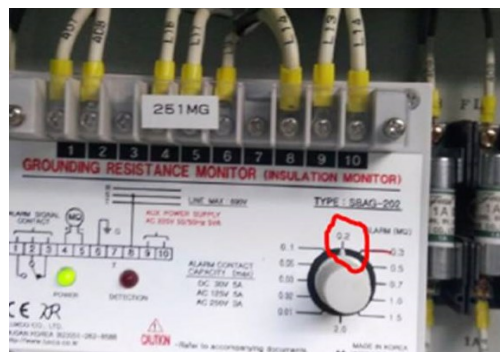
Note, in the photo to the left the earth alarm setting is 0.2 mΩ here such that this does not give much of a warning before a serious earth fault occurs. As a minimum the alarm setting should be 1 megaohm and ideally 2 or more mΩ to alert the user of early warning of potential problems.

Good practice suggests that a near to infinity as possible, but not less than 5 megohms, should be aimed for on the Insulation Monitoring Device (IMD). This should be achievable on a 440-volt system, but on a 220-volt system 2 megohms is acceptable due to the large number of parallel circuits.
