Inspector Bulletin

21st Jun 2021

VIQ 10.22 Where hydraulic aggregate pumps are located within the main engine compartment, is an oil mist detector fitted?

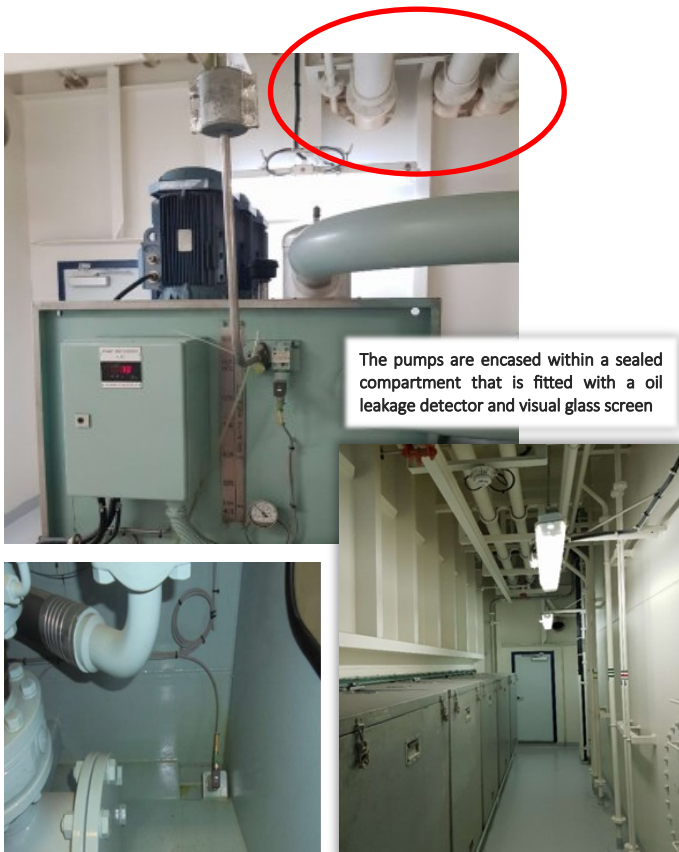
Inspector Observations: Hydraulic aggregates were located in a compartment within engine room; the space had about 12 pipe penetrations through the bulkhead with gaps around the pipes. In all about an area of 2.0 square meters was open while there was no oil mist detector fitted within the compartment.

Initial Operator Comments: The Framo hydraulic power pack pumps are located within a dedicated segregated compartment within the main engine compartment. The hydraulic pumps are fitted within a separate enclosure, inside the compartment, which is provided with oil leakage detectors and alarms.

The hydraulic power pack room is fitted with fire head/detection/alarm and fixed firefighting system. LR Class had been consulted regarding this matter previously and confirmed compliance with the Class and statutory regulations.

Regrettably OCIMF have not provided a definitive answer to this point, but the system meets class requirements here and a casing provided around the power packs with leakage alarm hence we do not consider this as an observation.
