Issue 7

Inspector Bulletin

Latest updates & News feeds for Inspectors. 2nd Aug 2019

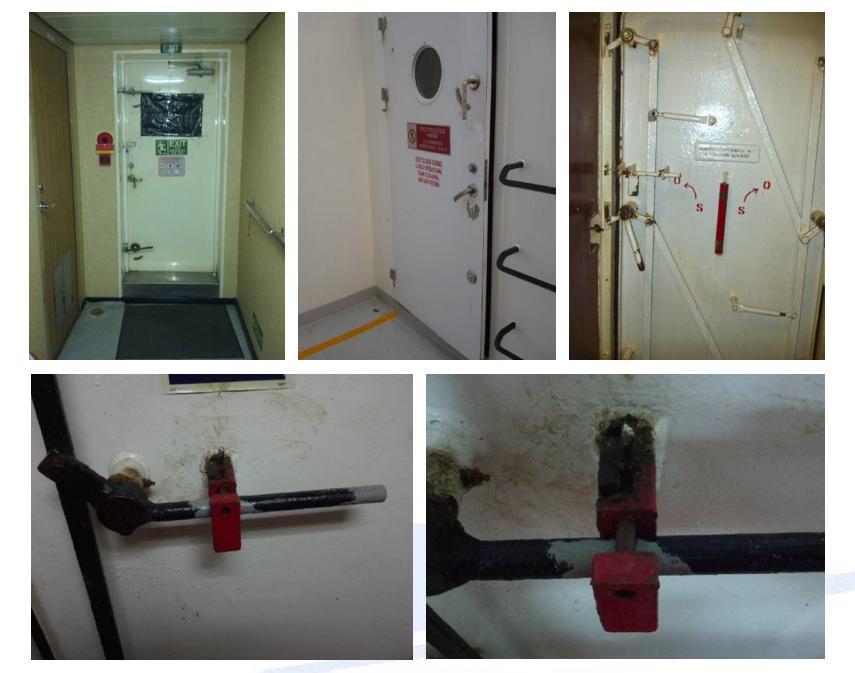
The subject of Safety vs Security was raised at the recent auditors meeting in Windsor and a valuable presentation by Tony Jones highlighted the issues and concerns. Below courtesy of Tony are examples of compromised safety situations on vessels external door preventing access from the outside in an emergency;

Inspector Observations: Accommodation door on main deck Stbd side was locked using a padlock which could be opened from inside by opening a butterfly nut. However the

shore based or emergency response team would require key for access to the accommodation.

I believe there is good need to challenge the operators comments here that are highlighted in green as the inspector clearly states the vessel was operating in security level 1 so why should the door be padlocked rather than sealed?

VIQ guidance states Doors should not normally be locked in port. However, where there are security concerns, measures may need to be employed to prevent unauthorised access while at the same time ensuring that there is a means of escape for the personnel inside. (ISGOTT 24.1)

OCIMF response to the issue of safety and security was discussed at the auditors meeting June 2019 and they stated that "security should be ensured, but not at the cost of safety and where situations are encountered onboard that suggest the compromise of safety then this should be recorded in the most appropriate question". This encourages observations to be raised accordingly where compartments are padlocked rather than sealed where there are low security concerns.

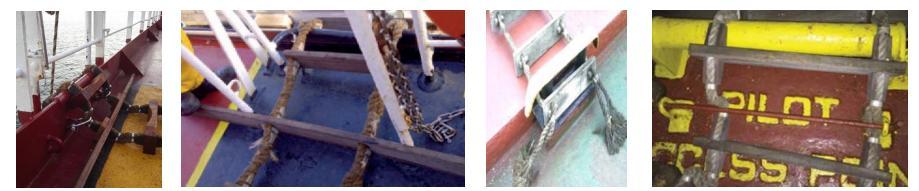
In all of the above cases the weight will fall onto the spreader itself rather than the actual ladder ropes.

The above methods of securing pilot ladders are incorrect; the correct way to secure a pilot ladder is by the use of rope lashings to the side ropes attached to approved strong lashing points on deck.

The pilot ladder should be directly lashed tightly to a ring plate provided near the ship's side for exclusive service, with no other items connected. If the full length of the ladder is

not used, each of the two stopper ropes of an adequate length should be connected to a rigid structure such as the ring plate

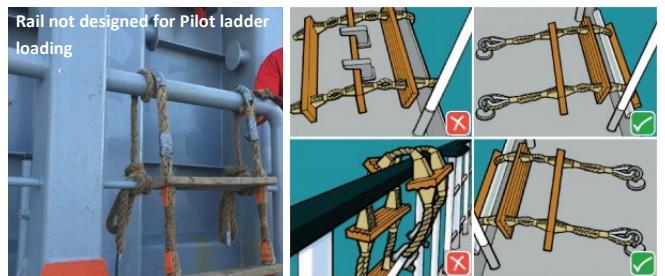
Pilot ladder secured using ship made brackets. The weight of the pilot will be supported by one step only. The hard edge of the top hull plate may damage the ropes

Pilot ladder should not be secured by shackles or trying to ship side rails. These rails are easily damaged and their strength cannot be guaranteed.

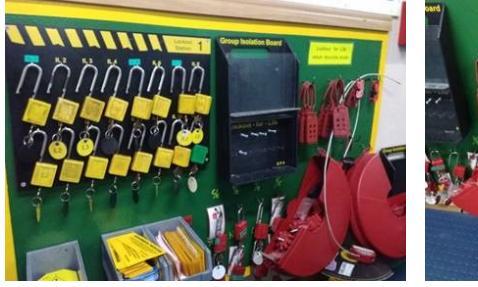
Here we have an excellent tag out and lock out system to complement the permit to work onboard;
