Issue 7

Inspector Bulletin

Latest updates & News feeds for Inspectors. 2nd Aug 2019

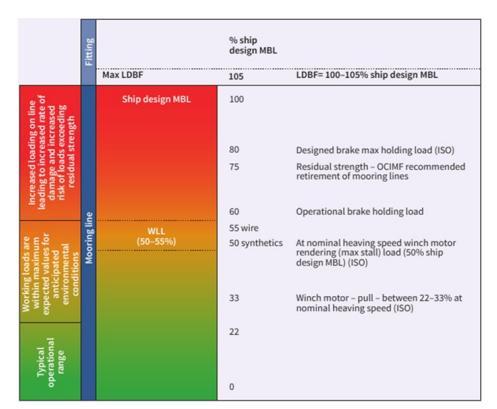
Working load limit (WLL) - The WLL is expressed as a percentage of ship design MBL and should be used as a limiting value in both ship design and operational mooring analyses. During operation, the WLL should not be exceeded. The WLL value is used as a limit with the standard environmental criteria and mooring layout when designing mooring systems.

The diagram extract from MEG 4 provides a good reference to the various settings;

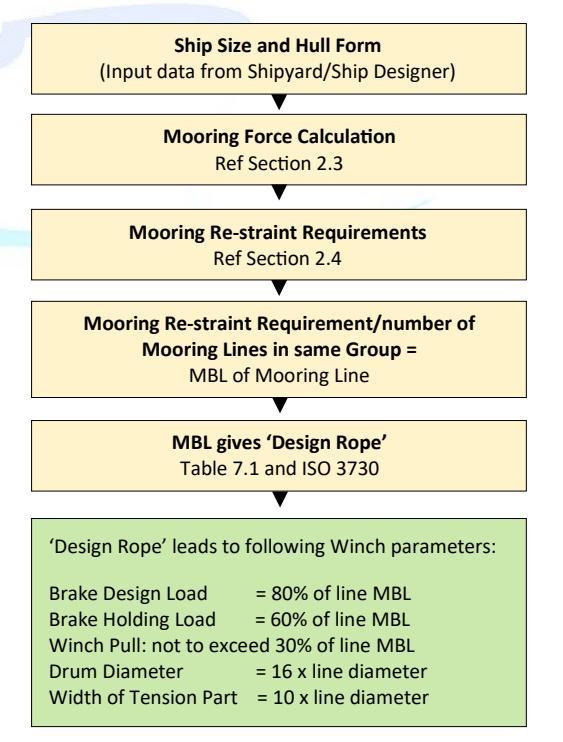
FIGURE 7.3: CALCULATION OF MOORING LINE MBL AND **RELATIONSHIP TO WINCH PARAMETERS**

Pre MEG 4 vessels should still follow the same guidance of setting their mooring winch brake rendering values based on the "line MBL" which, should be assumed to be synonymous with the ship design MBL, termed "Design Rope" MBL (See Figure 7,3 in MEG3).
