# Inspector Bulletin

Latest updates & News feeds for Inspectors. 06th Dec 2019

**VIQ 5.39** Are officers aware of the requirements for testing fixed fire detection and alarm systems and are the systems in good order and tested regularly?

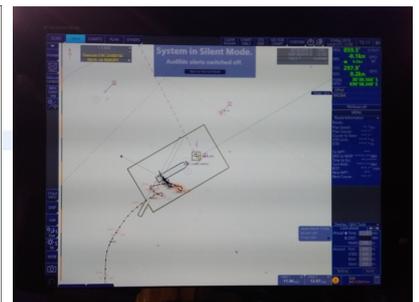
As a result of the CIC and in response to concerns raised by stakeholders across the maritime industry about the condition of in-service ECDIS, frequently found to have operational issues. Problems typically encountered included inadequate power supply arrangements, outdated software versions, disabled audio signal for alerts, and the incorrect functioning of interfaces to connected equipment. The purpose of the Guideline is to ensure that an in-service ECDIS is functioning properly, in the interests of safety of navigation and of course to meet ISM and SOLAS requirements.

Though the test is NOT mandatory it is recommended and inspectors should verify that there is a process in place for verifying the performance of the equipment annually. Makers maintenance instructions for ECDIS should also be included within the vessels planned maintenance program.
