Inspector Bulletin

Latest updates & News feeds for Inspectors. 12th Nov 2020

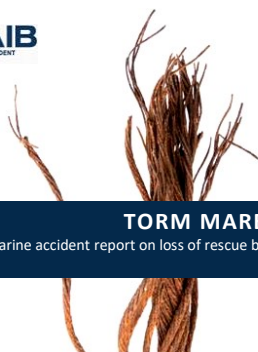
TORM MAREN

on the loss of rescue boat 1 APRIL 2020 where the rescue boat davit's wire rope parted, because it was corroded to the extent that its load bearing capacity was exceeded when the rescue boat was hoisted. However, the parting of the wire rope was an accident event which could not in itself explain why the rescue boat system failed. Even though the company's PMS instructed the officers to inspect and maintain the wire rope, they did not act upon the deteriorating condition of the wire rope. Neither did any of the other officers who continuously inspected, maintained and operated the rescue boat system even when the wire rope was readily visible.

The reason why the condition of the wire rope was not recognised as being detrimental to the functioning of the rescue boat system was a combination of three factors:

1. The manufacturer's manual and PMS which did not specify how to assess the condition of the wire rope.
2. An absence of training in assessing the wire rope's condition.
3. The PMS activities were compartmentalised which in practise meant that only one person was assessing each component. Additionally, all the factors were compounded by the thorough examination performed by service providers which made the officers trust not only the load bearing capability of the wire rope, but the man-riding capability of the system as a whole.
