Loss Prevention Bulletin

Crane Slewing Gear Maintenance and Rocking Tests

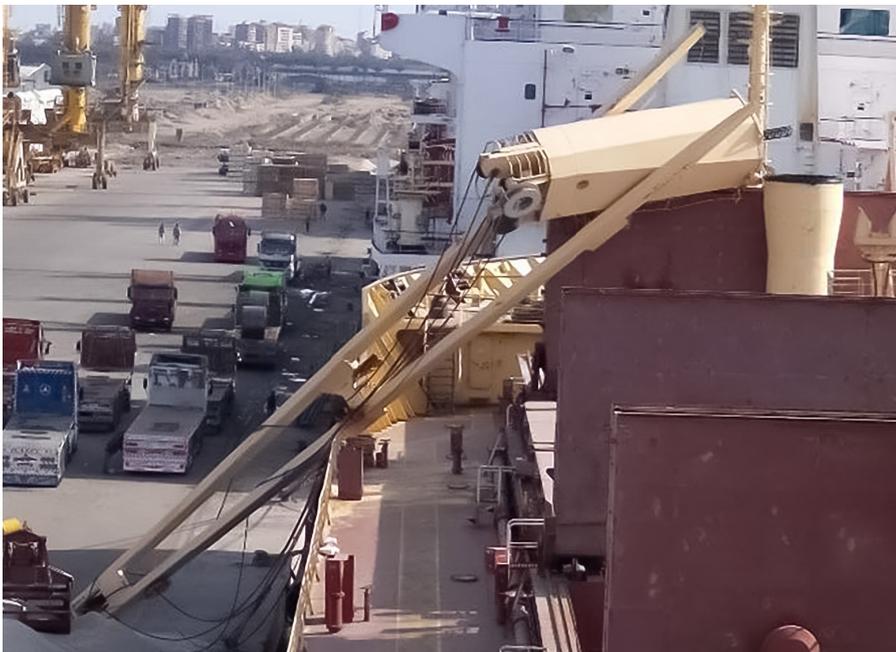
Courtesy of Transport Malta (© Copyright TM, 2018.) - [MSIU Report No. 02/2018 Final](#)

Incidents continue due to pedestal crane slewing gear's failure because of bearing wear, often leading to damage to equipment, cargo, significant repair delays and in events of catastrophic bearing failures, severe injury and fatalities. In many cases, the bearings fail with hook loads well below the crane's safe working load.

The slewing ring attached to the rotating crane body will be subject to the most wear at the rear of the crane body opposite the jib and under the jib itself, the former being subject to tension and the latter to compression caused by the weight of the jib and loads suspended from the hook.

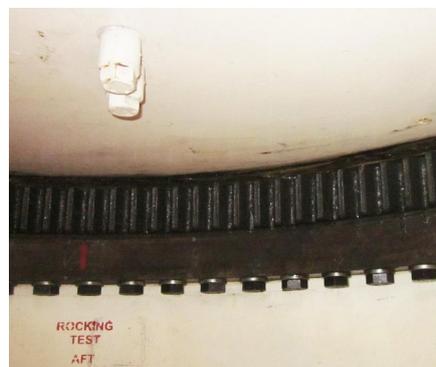
Courtesy of Transport Malta (© Copyright TM, 2018.)
[MSIU Report No. 02/2018 Final](#)

The rocking test comprises the measurement of the deflection between the crane pedestal and the rotating crane housing in the way of the slewing ring using a dial test indicator to determine the bearing clearances.

Measurements are taken at the two locations on the slewing ring susceptible to the most significant bearing wear, under the jib's centre and diametrically opposite. A set of eight readings are taken with the crane pointing dead ahead, dead astern, to port and then to starboard, initially with the jib luffed to its minimum radius with no weight on the hook and then with the jib luffed to its maximum radius with the difference between the two readings giving the bearing clearance.

The readings are compared against the manufacturer's maximum permissible clearance, which will depend on the type and size of the slewing ring and bearing size. The original bearing clearances should be available to determine the degree of wear. Consider shortening the testing intervals when the noted wear has increased appreciably between consecutive rocking tests.
